Convertible Top Tonneau Cover Damage

This bulletin involves installing two vinyl caps to the ends of the deck lid mounted tonneau cover tensioner.

2003 - 2005 (ZB) Viper

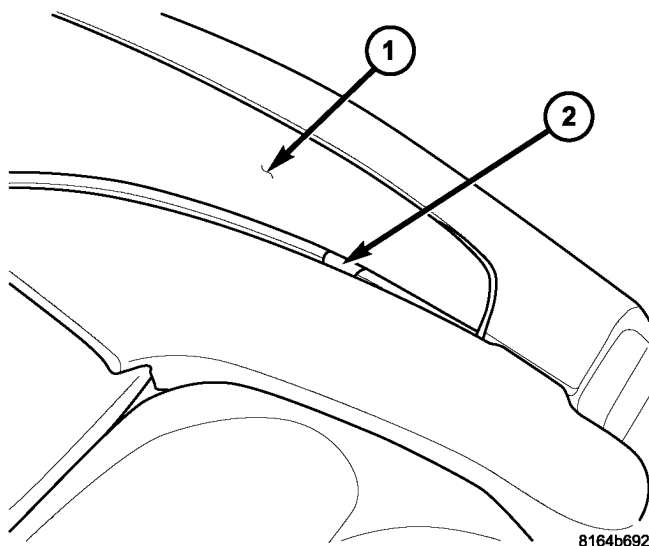
Potential for damage to the convertible top tonneau cover, (Fig. 1). The deck lid mounted tonneau cover tensioner ends contact the convertible tonneau cover when it is installed. Over time and road input, a tear in the tonneau cover material may develop.

**Fig. 1 POINT OF WEAR ON TONNEAU COVER**

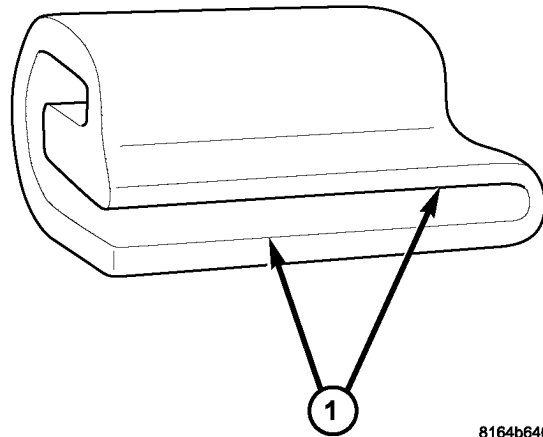
**Fig. 2 BOND-ALL GEL APPLICATION**

1. Open the deck lid.
2. Prepare deck lid tonneau cover tensioner surface where the protective cap will be installed, (Fig. 3), by cleaning with an isopropyl alcohol or napatha wipe, allow time for surface to dry completely prior to applying the protective caps.
3. Apply a small amount of Mopar Bond-All Gel, p/n 04467709, to the inside surfaces of the right side protective cap, p/n 05030298, (Fig. 2).

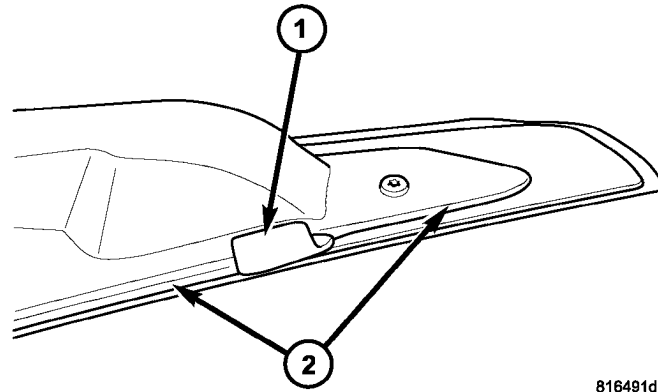
**Fig. 3 VINYL CAP INSTALLATION**

4. Position the protective cap, p/n 05030298, to the right side end of the deck lid tonneau cover tensioner and slide over the end of the tensioner, (Fig. 3).

5. For proper bonding, the cap must be secured by applying pressure for a minimum of 20 seconds. A clamp may be used.
6. Repeat steps 2 - 5 for the left side using left side protective cap, p/n 05030299.
7. The adhesive is completely cured in 24 hours. The deck lid can be operated in 20 minutes after the caps are installed.
