Dealer Service Instructions for:

Safety Recall No. C27 – Fuel Pump Wiring

2003 (ZB) Dodge Viper

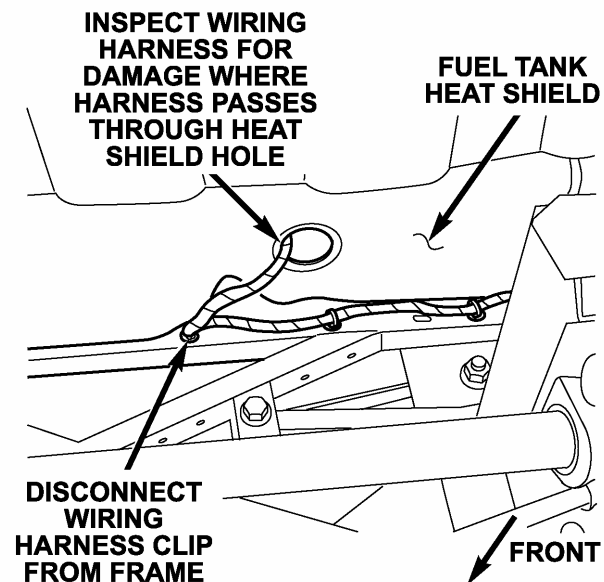
Figure 2

The fuel pump wiring harness on 69 of the above vehicles may become chafed by the fuel tank heat shield. This could cause the engine to stall which can result in an accident without warning.

1. Raise the vehicle on an appropriate hoist.
2. Remove the 21 rear extension belly pan-to-rear fascia bolts and the four (4) rear extension belly pan-to-frame bolts and then remove the rear extension belly pan (Figure 1).
3. Remove the fuel pump wiring harness clip from the frame hole (Figure 2).
4. Inspect the fuel pump wiring harness for damaged wire insulation where it passes through the hole in the fuel tank heat shield (Figure 2). Wrap any damaged wires with high quality electrical tape.
