NUMBER: 23-007-03

Center Console Lid Hard to Latch or Unlatch

2003 (ZB) Viper

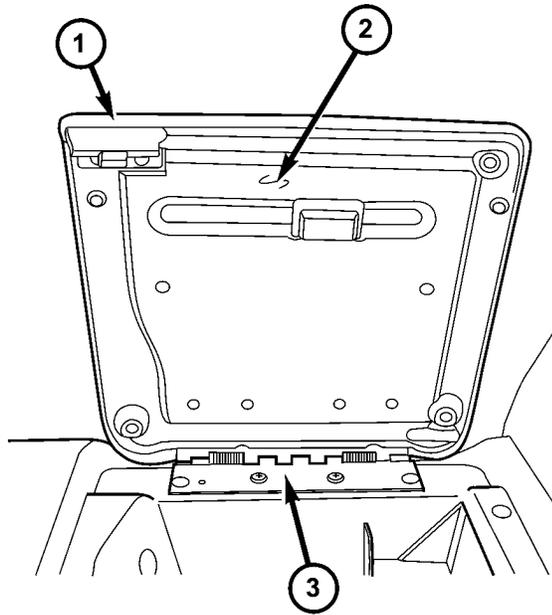
Fig. 1 CONSOLE LID

Vehicle operator may experience that the center console lid is hard to latch or unlatch.

1. Open console lid.
2. Remove 4 console hinge attaching screws (Fig. 1).
3. Place the console lid assembly on a clean shop cloth on a suitable bench.
Remove 11 screws from the inner console lid.

4. Remove the hinge from between the inner console lid and the upper console lid (Fig. 1).
5. Install new hinge (p/n 05114426AA) between inner console lid and the upper console lid.
6. Loosely install the 11 screws in the inner console lid. After all screws are started, torque the screws to 1.4 Nm (12 in. lbs.).
7. Loosely install the front and rear screws mounting the assembly to the console. After both screws are started, torque the screws to 1.4 Nm (12 in. lbs.).
8. Install the two center screws mounting the assembly to the console. Torque both screws to 1.4 Nm (12 in. lbs.).
9. Insure the console opens and closes properly.
