SERVICE BULLETIN

NUMBER: 23-025-05

Deck Lid Closing Effort

2003 - 2005 (ZB) Viper SRT10

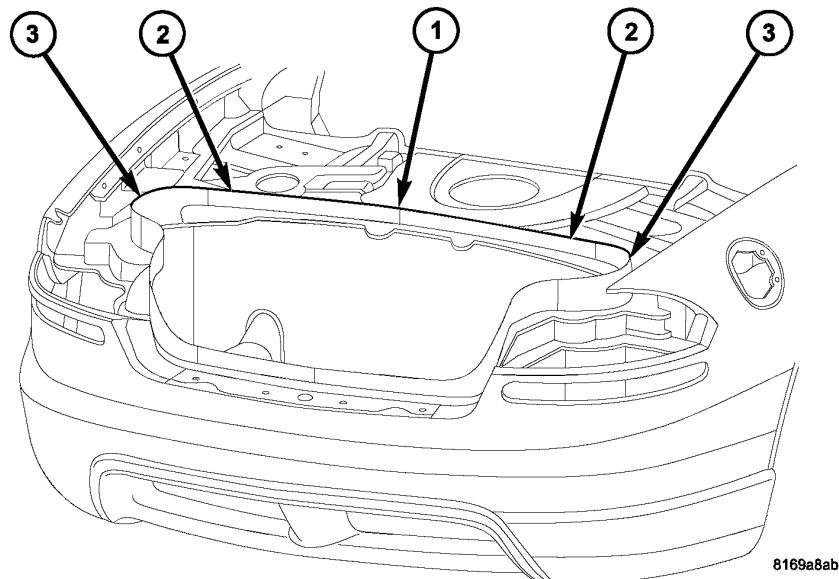
Fig. 1 TRUNK WEATHERSTRIP MOUNTING FLANGE REVISION

Deck lid is difficult to close.

The deck lid should close from a maximum height of 400mm (16 in.), without over slam.

1 - REMOVE 3mm OF FLANGE HEIGHT

2 - REMOVE 2mm OF FLANGE HEIGHT

3 - REMOVE 0mm OF FLANGE HEIGHT

1. Remove trunk weatherstrip along the forward mounting flange ([Fig. 1](#)).
2. Mark the inboard edge of the forward trunk weatherstrip mounting flange with masking tape to outline the material to be removed, 3mm (0.118 in.) at the center of the flange and reduce to zero toward the outboard ends of the flange as illustrated, ([Fig. 1](#)).

3. Reduce the forward trunk weatherstrip mounting flange height by filing/grinding away material along the edge of the tape placed in step 2.
4. Remove the masking tape.
5. Clean (vacuum) the area of all debris.
6. Install trunk weatherstrip.
7. Close the deck lid and check the effort required.
8. Adjust deck lid latch striker down as necessary, 2mm (0.079 in.) maximum. Torque the latch striker bolts to 12Nm (105 in. lbs.).
