NUMBER: 23-027-03

Instrument Panel Rattle Sound

This bulletin involves modifying the IP center defroster duct.

2003 - 2004 (ZB) Viper

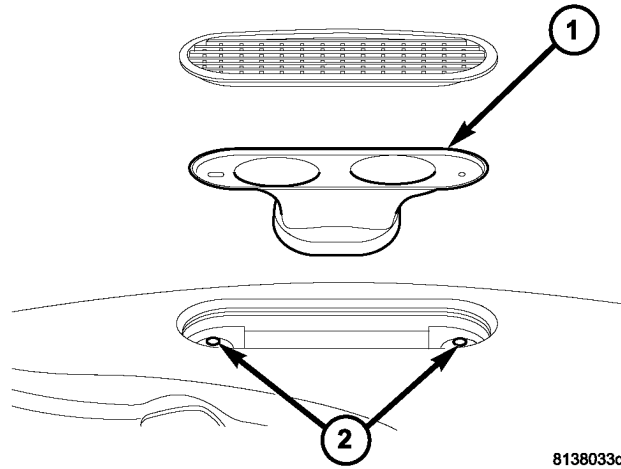
Fig. 1 MODIFY DEFROSTER DUCT

Rattle sound from IP defroster grille area may be heard when driving over rough road surfaces. The defroster duct flange is touching bottom of defrost grille and/or IP substrate.

- 1 - REMOVE THE UPSTANDING FLANGE
- 2 - DUCT RETAINING SCREWS

1. Remove the defroster grille from IP (using trim stick or equivalent).
2. Remove the defroster duct mounting screws (2) and defroster duct (Fig. 1).
3. Using snips/cutters, remove upstanding flange around entire outlet side of duct (Fig. 1).

- 4. Remove any loose debris from the defroster duct area.
- 5. Reinstall duct with two screws, tighten the screws to 1.6 - 2.2 Nm (14 - 20 in. lbs.).
- 6. Reinstall defroster grille making sure it is secure around entire outside edge.
