NUMBER: 23-030-03

DATE: December 12, 2003

Convertible Top To Door Contact

2003 - 2004 (ZB) Viper

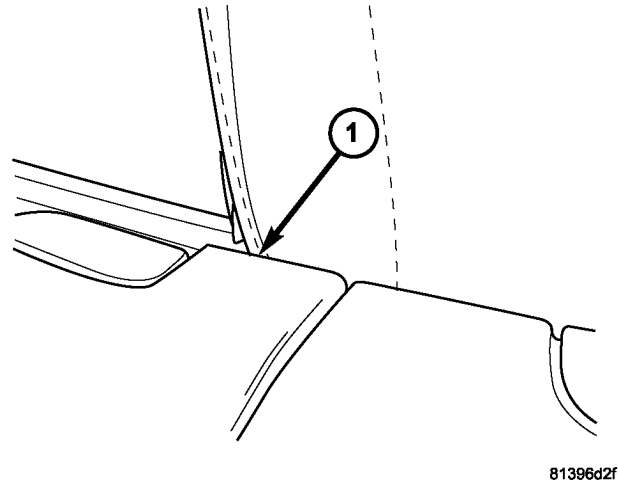
Fig. 1 TOP TO DOOR MEASUREMENT

The lower edge of the convertible top may contact the door. This condition may cause the vehicle paint to wear off the inner door and transfer the paint onto convertible top cloth.

Make sure the top is in the full closed (up) position and latched. Close both doors with the windows up. Use a metric rule to check the gap/clearance of the lower binding edge of the convertible top to the edge of the door (Fig. 1). The gap/clearance should equal 1 - 4mm. If gap/clearance is less than 1mm or if hard contact between the top and door is made, perform the Repair Procedure.

1 - CLEARANCE 1-4 mm
